## AVK SMART AIR VALVE PREVENTS POLLUTION INCIDENT AT UK'S FIRST DESIGNATED RIVER BATHING WATER SITE

### How VIDI is Helping to Address Network Challenges

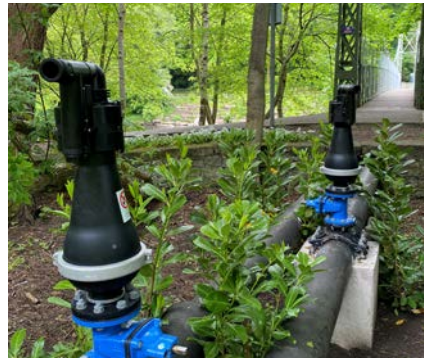
In 2021, Yorkshire Water trialled ARLsense smart water valve technology in Kilnsey, a small village in North Yorkshire. The trials proved successful and led to two DN80 ARLsense smart water air valves being installed on a 225mm ductile iron rising main sewage pipe which, for a short distance, runs close to the River Wharfe. Standard air valves are vital to network efficiency and safety. However, in areas where FOG (fats, oils, greases) pollution builds up, there is a risk of the air valve clogging. In turn, this could lead to the discharge of untreated sewage into the local environment.

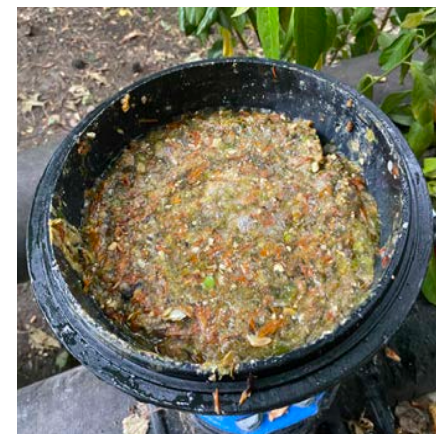
The ARLsense smart air valve alerts the Yorkshire Water operations team when there is clogging, overflow risk or leakage. In the most recent incident, the ARLsense smart water air valve alarmed after detecting a potential overflow risk. Responding quickly to the alarm, the Yorkshire Water team identified that the air valve had clogged with fats, oils and greases to the point that the integral float was no longer operative risking an escape of untreated sewage.

'At Ilkley, there were two primary risks caused by the FOG blockage. Firstly, the sewage pipe risked bursting due to vacuum or over-pressurization as the air valve was not functioning due to the blockage; a burst would have caused considerable damage and pollution. Secondly, the blockage had caused the air valve's float to cease functioning. The float acts to seal the valve and, if this is not the case, there is a risk that raw sewage would have poured out from the valve itself.'
